INVESTIGATION TO THE CAUSE OF
THE CRASH OF A BOEING 737 NEAR
AMSTERDAM SCHIPHOL ON
FEBRUARI 25TH 2009
&
LESSONS to be LEARNED

by:
Jos van Ruitenbeek
(Member of Aviation Committee of OvV)

- On februari 25th 2009 a Boeing 737, on a flight from Istanbul to Amsterdam, crashed during the approach to the Polderbaan.
- The Dutch OvV did an investigation to determine the cause of the accident.

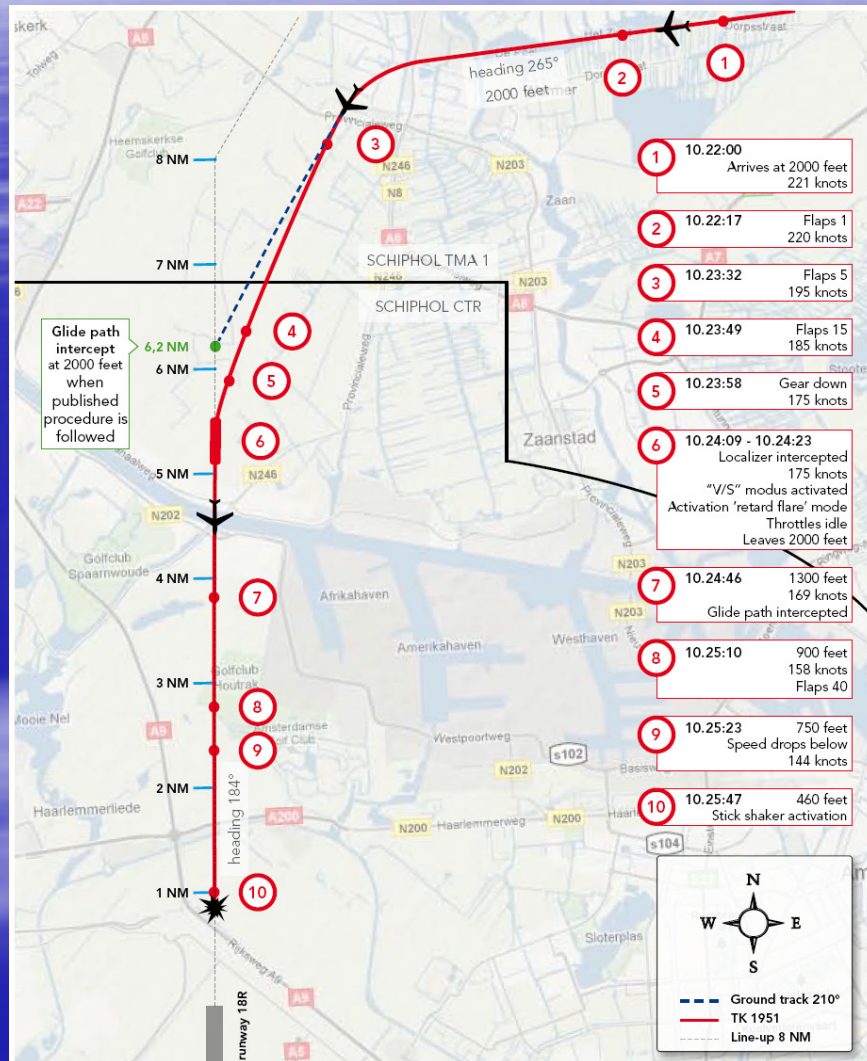
4. History of the flight (approach phases)

4-6. Interception of the localizer signal and activation of the retard mode

- This time segment (10.24:09 - 10.24:23 hours) starts with the interception of the localizer signal.
- The glide path is, subsequently, approached **from above** from an altitude of 2000 ft, using V/S mode.
- The thrust levers automatically **go to idle**.
- The autothrottle flight mode annunciation changes to '**RETARD**'.

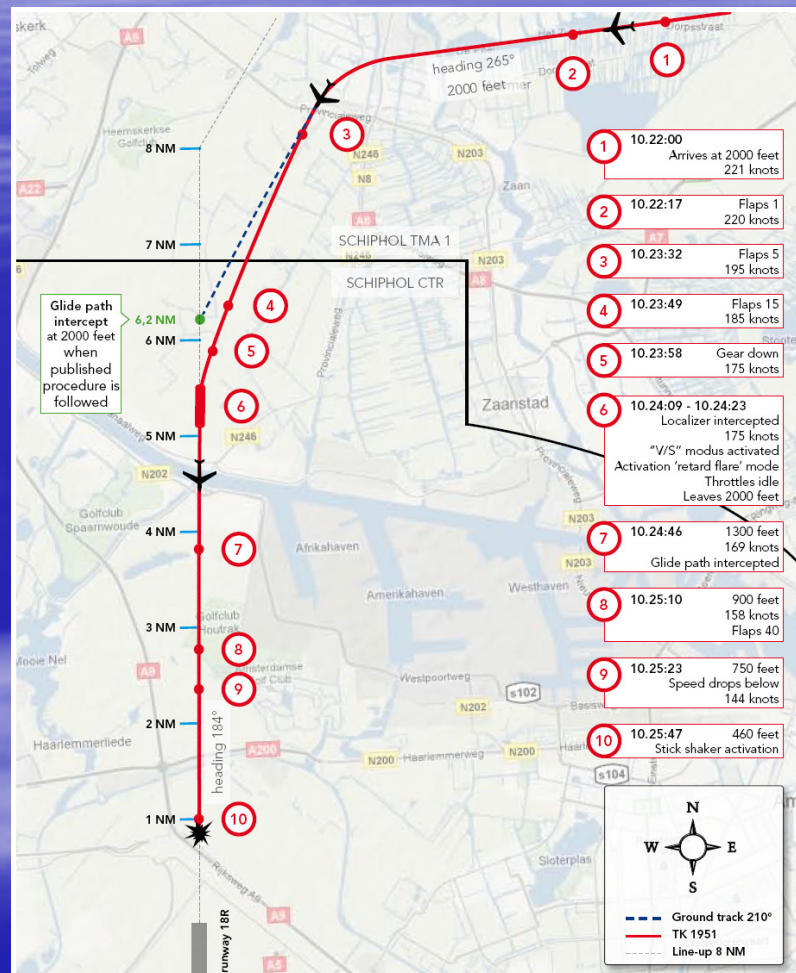
4. History of the flight (approach phases)

8-9 Air speed drops below the selected value

- In this phase the **speed drops** below the selected speed of 144 knots.
- The aircraft descends to 500 ft.
- The distance to the runway threshold is about 2,5 NM.

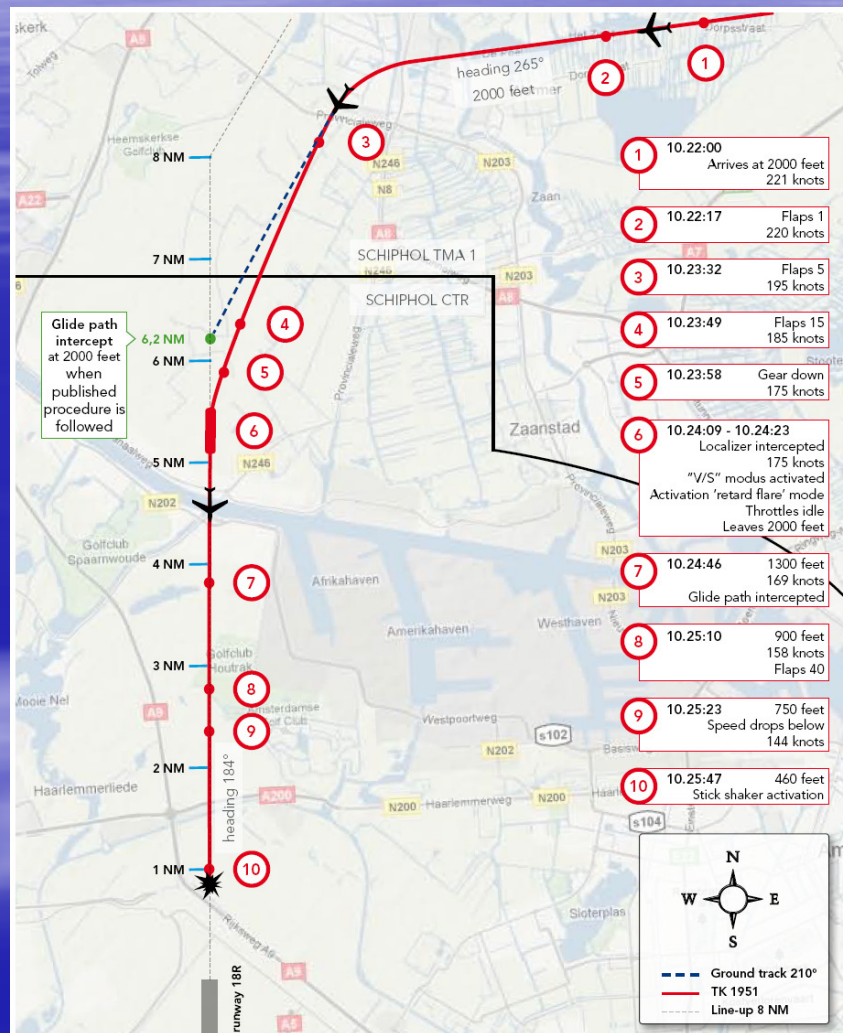
4. History of the flight (approach phases)

10. Activation stick shaker

- This time segment starts with the activation of the stick shaker and ends with the aircraft's accident.

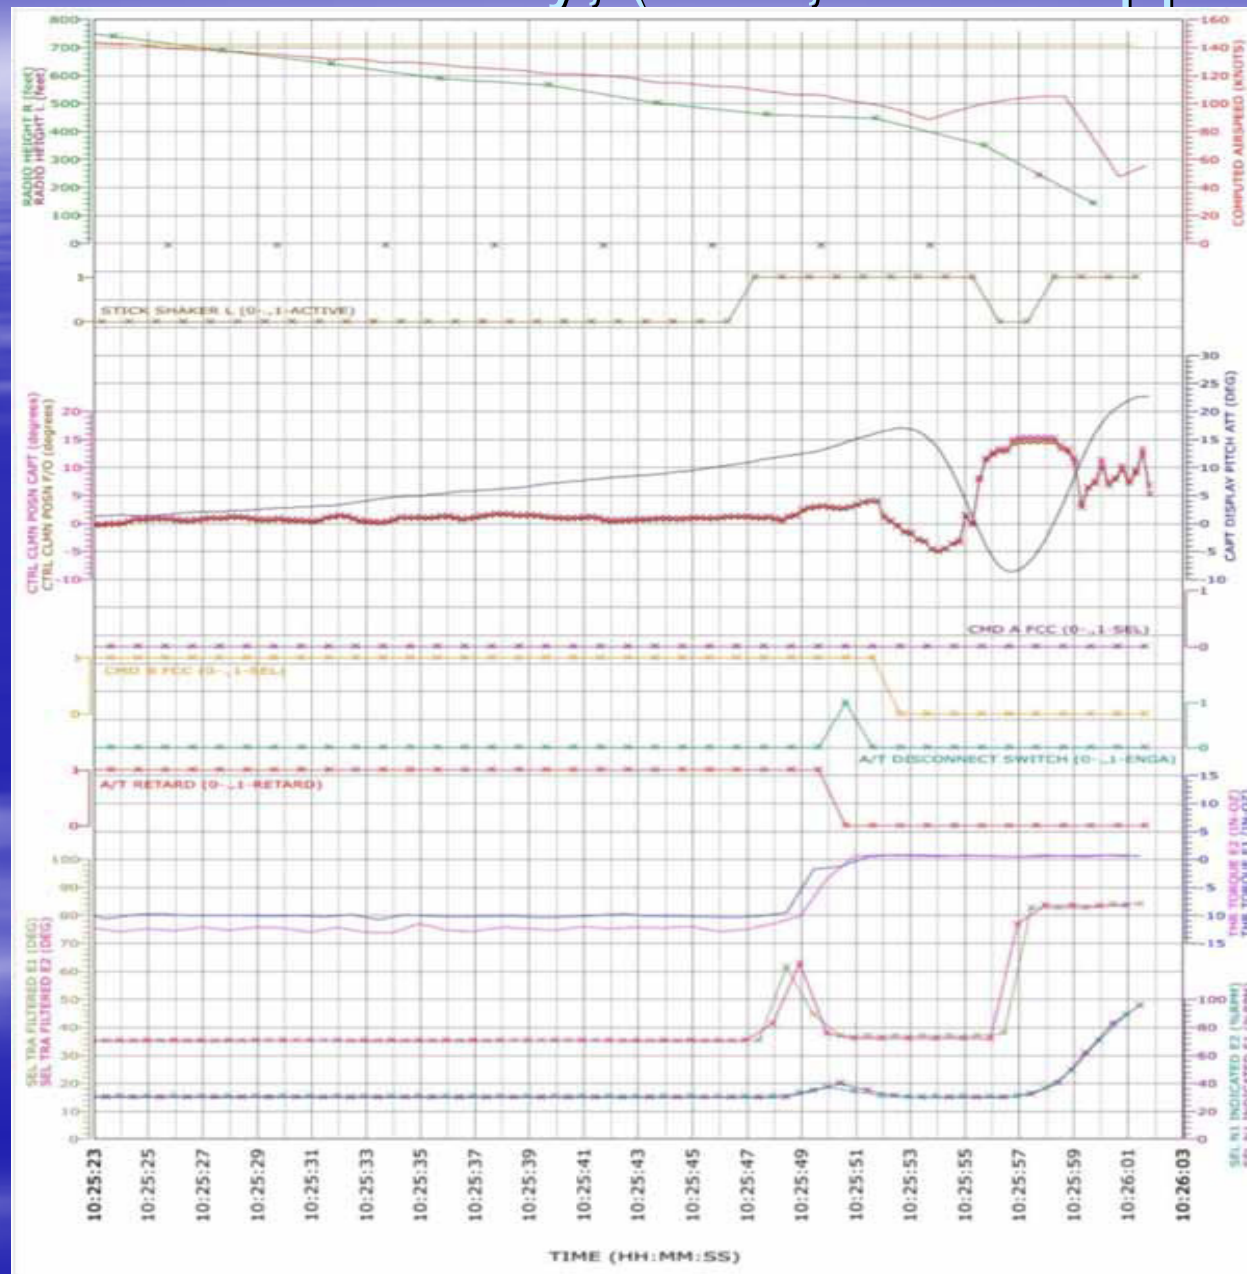
6. Facts: Stall recovery, (FDR, Thrust application)

1. LIFUS flight
2. Malfunction of Radio alt
3. Crew unaware of consequence of Radalt malfunctioning
4. Short turn in, without descent, non-requested, but accepted
5. RETARD mode not remarked by crew, crew did not take action on reducing airspeed, or on the throttles remaining closed
6. High workload (LIFUS, Short turn in, Intercept of G/S from above)
7. No Go-around at 1000 ft as not stabilized
8. Inadequate stall recovery, No full thrust, Auto throttle was disconnected **after** applying thrust, too late.
