INVESTIGATION TO THE CAUSE OF
THE CRASH OF A BOEING 737 NEAR
AMSTERDAM SCHIPHOL ON
FEBRUARI 25TH 2009
&
LESSONS to be LEARNED

by:
Jos van Ruitenbeek
(Member of Aviation Committee of OvV)

- On februari 25th 2009 a Boeing 737, on a flight from Istanbul to Amsterdam, crashed during the approach to the Polderbaan.
- The Dutch OvV did an investigation to determine the cause of the accident.

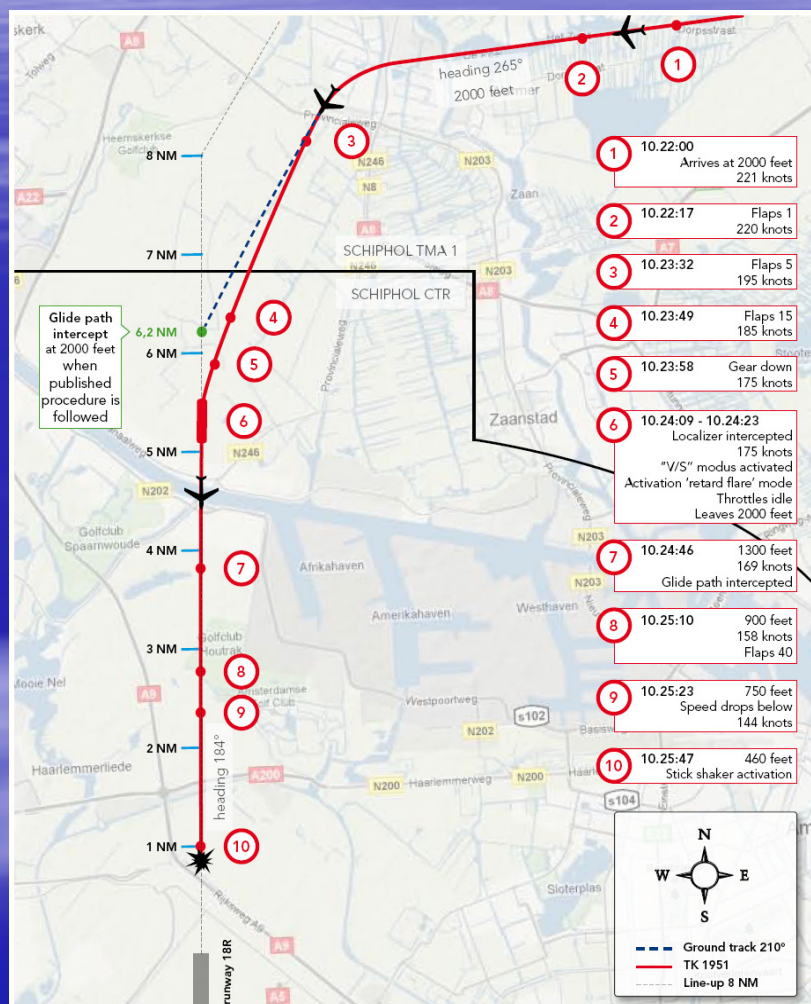
2-3. Landing gear warnings

- This time segment (10.15:02 - 10.22:37 hours) starts with radio contact with Schiphol approach.
- 4 times an audio warning regarding the landing gear can be heard during this period.
- TK1951 is on a 265 degrees heading at 2000 ft and the flaps are selected in position 1 at the end of this time segment.

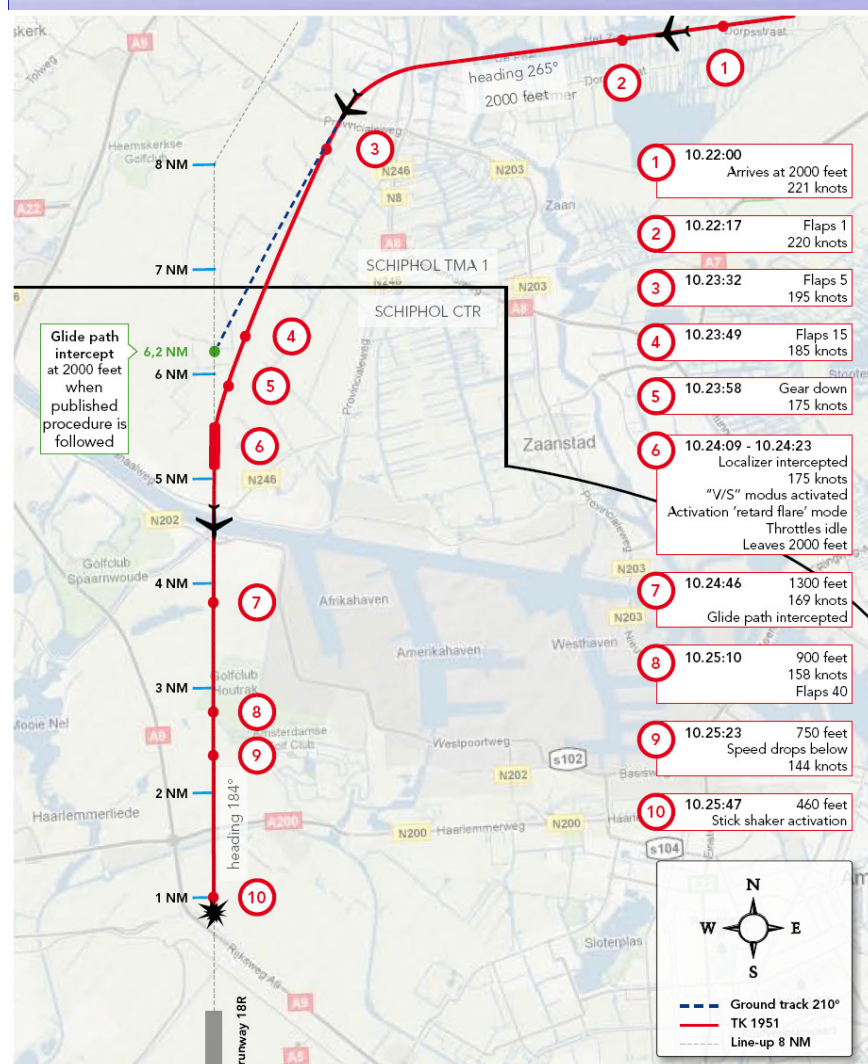
3-4. Aligning for the final approach and landing gear configuration warning

- This phase (10.22:38 - 10.24:08 hours) starts with the instruction to fly heading 210 degrees and permission to start the approach.
- The audio **warning** with regard to the **landing gear** can be heard again.
- The landing gear is selected down and the flaps are in position 15 by the end of this time segment.
Landing gear warning stops!

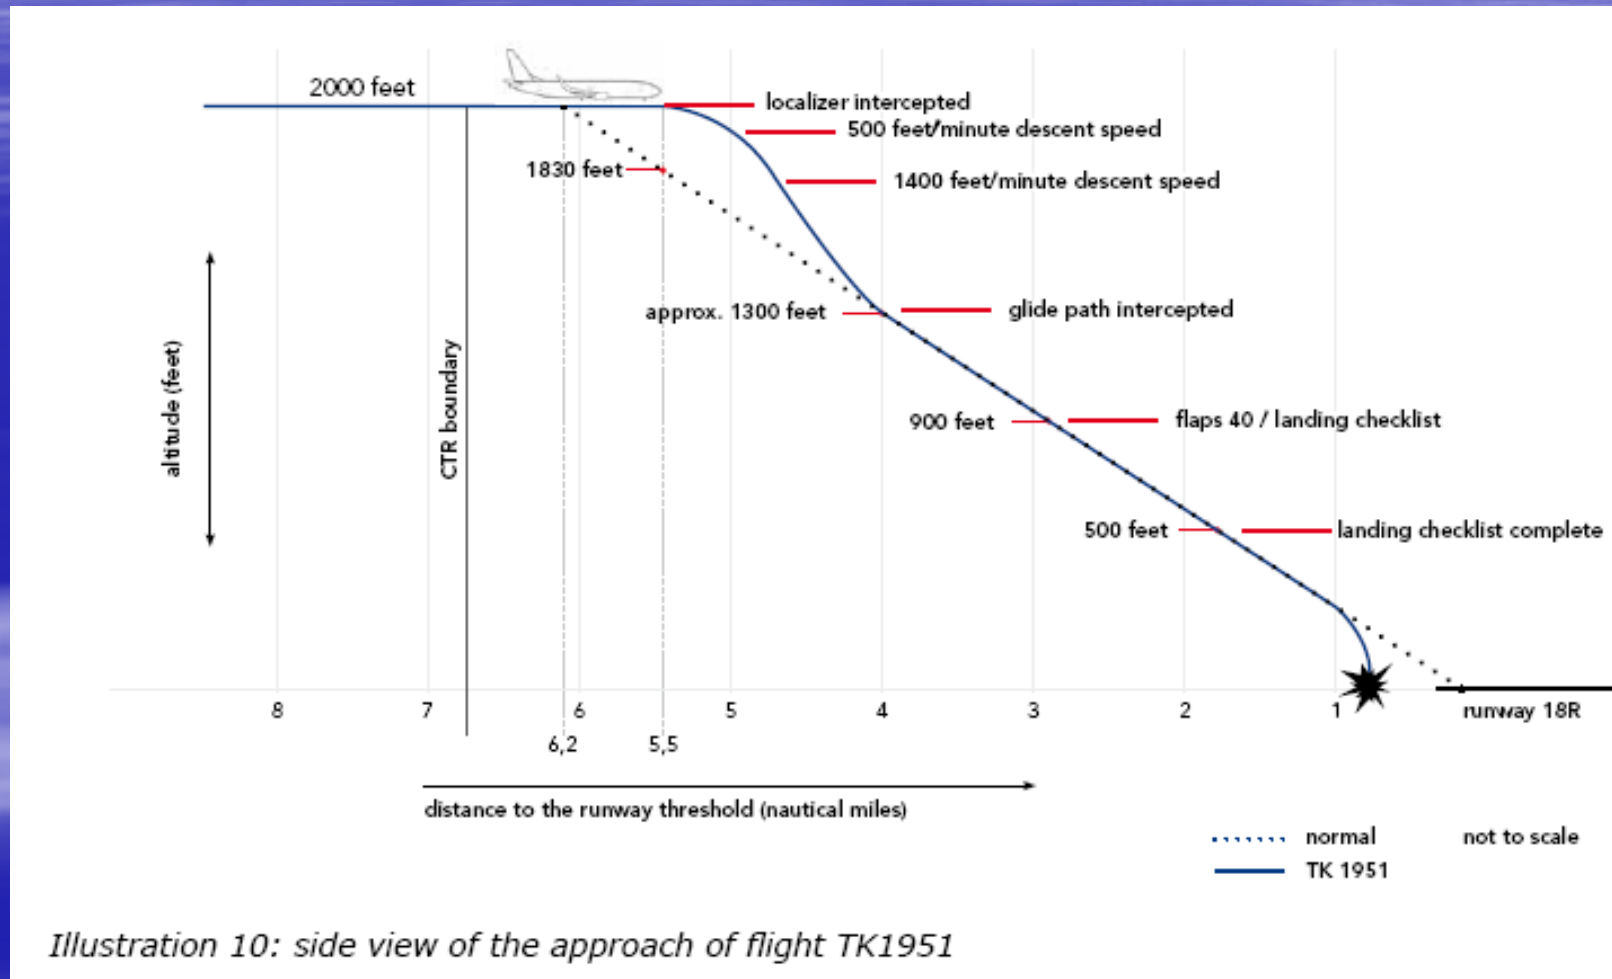
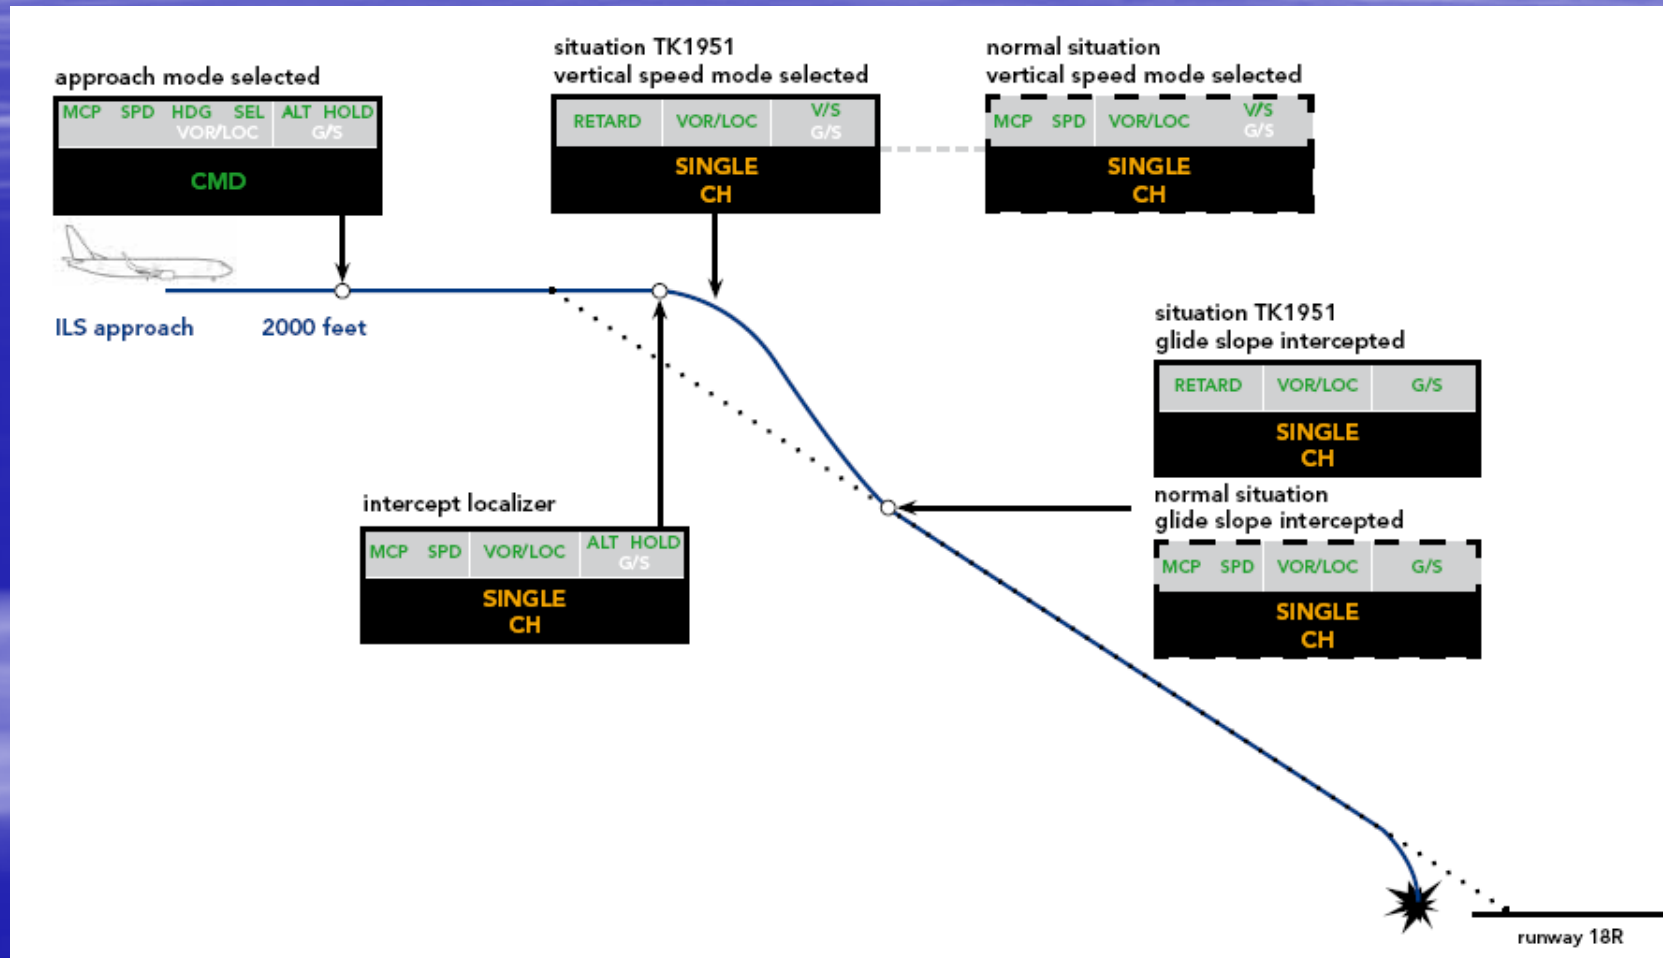
4. Flight Mode Annunciations during approach

- The 'vertical speed' mode was selected to intercept the G/S from above.
- Usually, when this mode is selected, the corresponding 'MCP speed' mode will be activated for the autothrottle. However the 'Retard flare' mode of the autothrottle was activated.
- With this 'RETARD' appeared on the Flight Mode Annunciation of both Primary Flight Displays.
- With regard to the Boeing 737 NG series the 'Retard flare' mode is activated when the autothrottle is in use and certain conditions have been met, under which, a radio height less than 27 ft.
